RCRA SAMPLING REPORT

INSPECTION DATE: May 4, 2017

SITE NAME: Container Life Cycle Management, LLC
d/b/a Mid-America Steel Drum, Inc.

EPA ID NUMBER: WIR 000 131 367

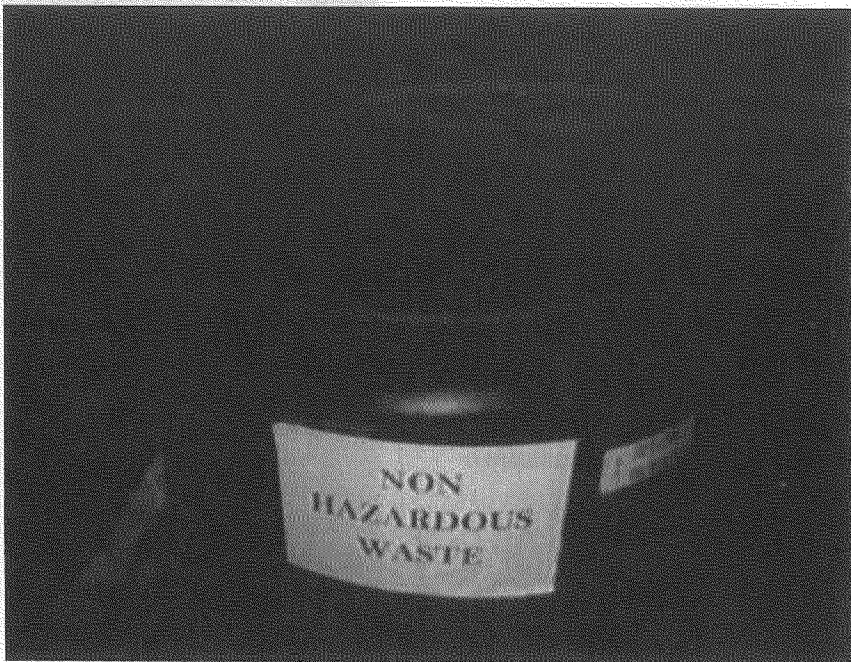
Storage of "heavies." One 55-gallon container was labeled as Non Hazardous Waste. SFS09. Sampled 3:23pm. Full contents. pH paper showed pH of 10. 8 aliquots each sample jar. 4 x 16 oz sample jars were filled. Split taken.

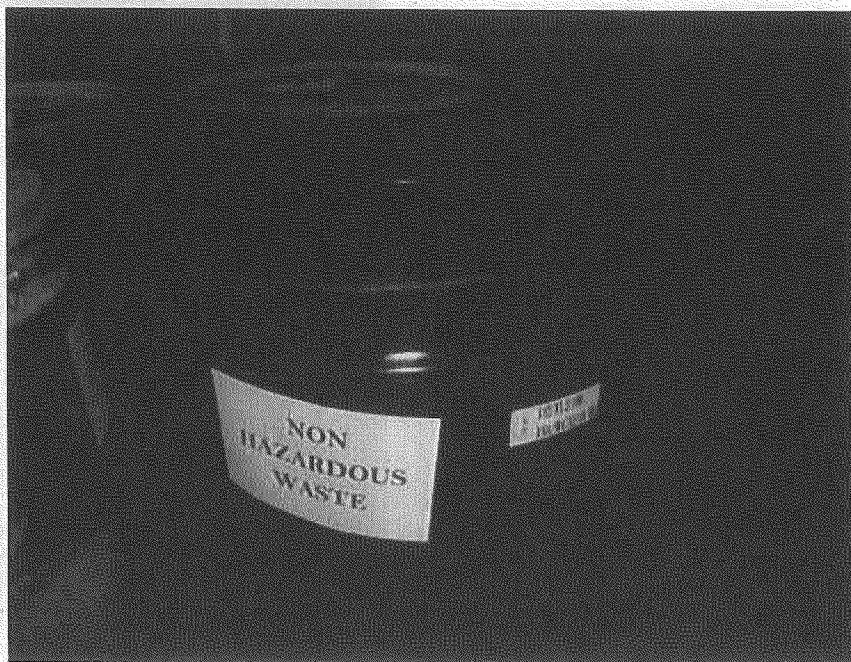
Disk Number 1
Photo Number 60
Photo Filename DSCN1120.JPG
Date/Time 5/4/2017
3:19:00 PM
Photographer Jamie Paulin

Storage of "heavies." One 55-gallon container was labeled as Non Hazardous Waste. SFS09. Sampled 3:23pm. Full contents. pH paper showed pH of 10. 8 aliquots each sample jar. 4 x 16 oz sample jars were filled. Split taken.

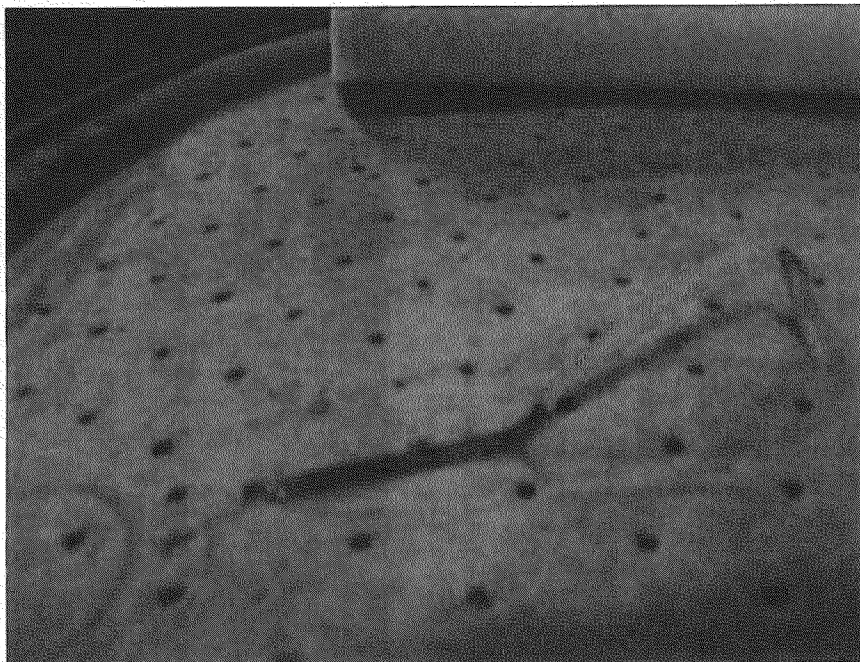
Storage of "heavies." One 55-gallon container was labeled as Non Hazardous Waste. SFS09. Sampled 3:23pm. Full contents. pH paper showed pH of 10. 8 aliquots each sample jar. 4 x 16 oz sample jars were filled. Split taken.

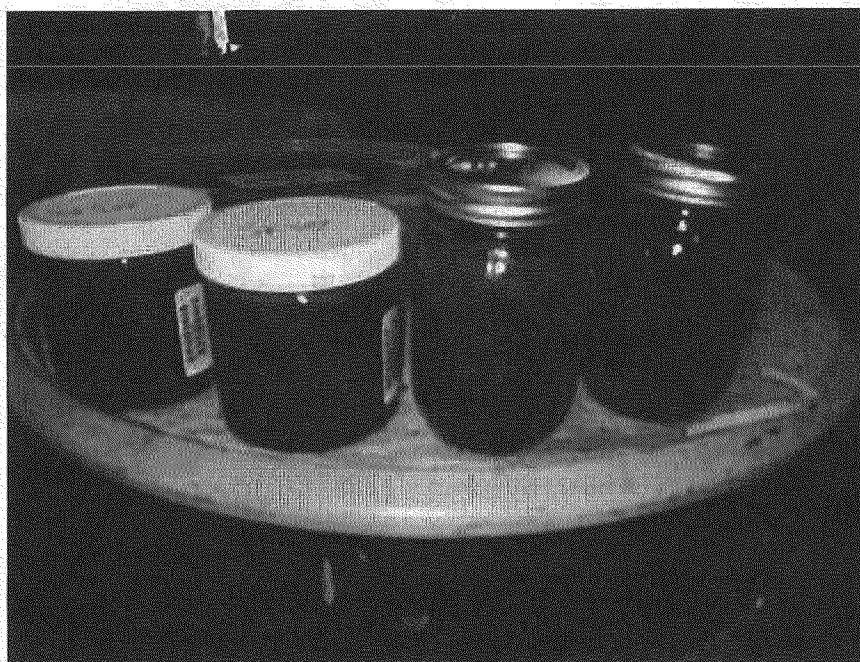
Disk Number 1
Photo Number 62
Photo Filename DSCN1122.JPG
Date/Time 5/4/2017
3:31:00 PM
Photographer Jamie Paulin

Storage of "heavies." One 55-gallon container was labeled as Non Hazardous Waste. SFS09. Sampled 3:23pm. Full contents. pH paper showed pH of 10. 8 aliquots each sample jar. 4 x 16 oz sample jars were filled. Split taken.

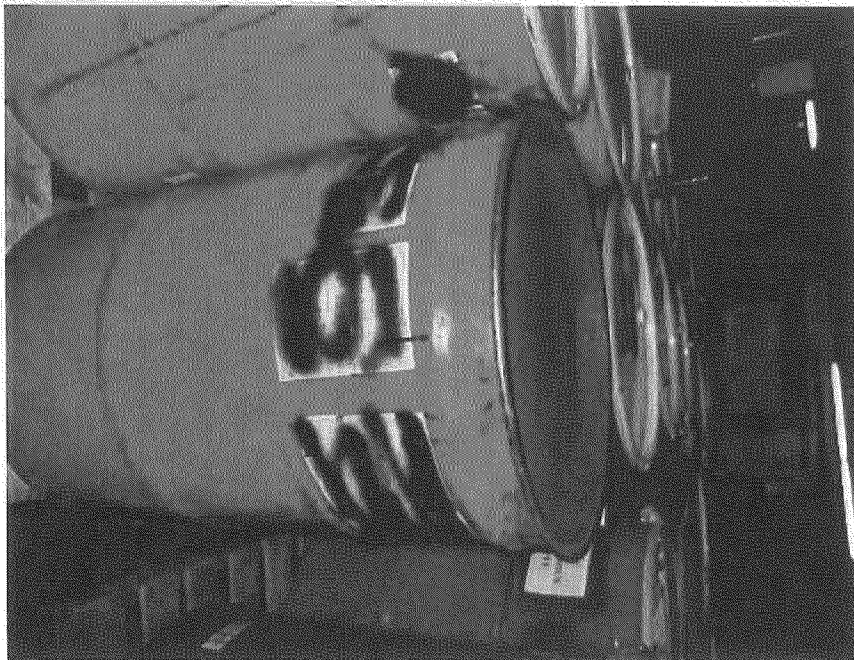
Sample No.	Time Taken (CST)	Additional Observations	Photo Number
SFS10	3:37 PM	Red steel open-top drum with no clear marking or label Material was a very fine gray dust. Drum was almost full. Two full 16 oz. jars taken with three scoops per jar	63 – 64
SFS10 Dup	3:37 PM	Red steel open-top drum with no clear marking or label Material was a very fine gray dust. Drum was almost full. Two full 16 oz. jars taken with three scoops per jar.	63 – 64

Storage of "heavies." One 55-gallon container was labeled as Non Hazardous Waste. SFS10. Sampled 3:37pm. Full contents. 3 scoops each sample jar. 4 x 16 oz sample jars were filled. Split taken. Duplicate taken.

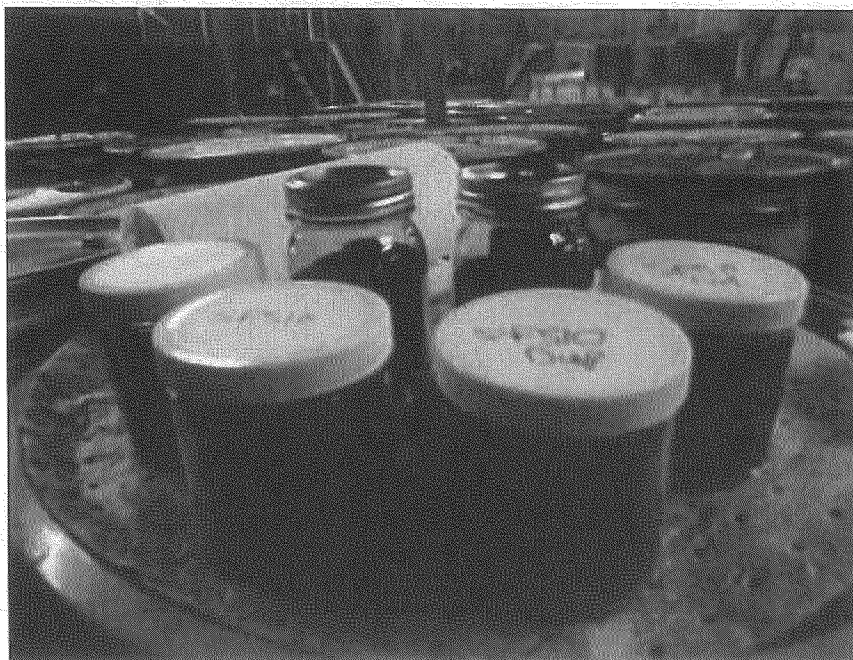
Disk Number 1
Photo Number 64
Photo Filename DSCN1124.JPG
Date/Time 5/4/2017
3:43:00 PM
Photographer Jamie Paulin

Storage of "heavies." One 55-gallon container was labeled as Non Hazardous Waste. SFS10. Sampled 3:37pm. Full contents. 3 scoops each sample jar. 4 x 16 oz sample jars were filled. Split taken. Duplicate taken.
